ORIGINALLY ISSUED  
November 1944 as  
Memorandum Report L4K14

ACCELERATIONS AND BOTTOM PRESSURES MEASURED ON A  
B-24D AIRPLANE IN A DITCHING TEST

By Margaret F. Steiner

Langley Memorial Aeronautical Laboratory  
Langley Field, Va.

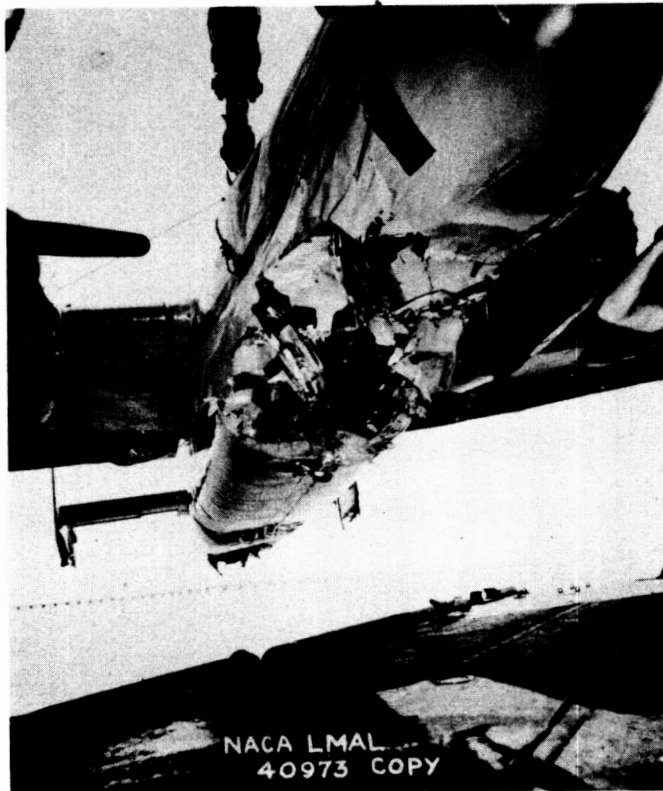
The pressure distribution holds for this reinforced airplane with its specific damage. The distribution would be different for a normal airplane in a ditching or for an airplane which remained undamaged. Figure 16 is a photograph of the B-24D fuselage bottom taken just after the airplane was retrieved from the James River. Note the damage in the nose-wheel area, the dent in the rear bomb doors, and the hole near bottom turret. Rudders were slightly damaged and the skin was indented over the lower half of the fuselage in a strip just in front of the empennage.

Immediately after first contact the area just aft the  $\frac{1}{8}$ -inch steel plating was forced inward, the skin was crushed at a section of the fuselage tail near the rudder hinge line, and the rudders were damaged.

the airplane rocked forward with the port wing low. These high pressures failed the bottom area just in front of the walkway. As the nose plowed through the water the steel reinforcement over the bombardier's sighting window was dented at which time the maximum decelerations also occurred. The damage around the nose-wheel door section apparently weakened the structure to such an extent that the nose section was almost broken away from the rest of the airplane.

Figure 16.- Photograph of B-24D fuselage bottom taken after airplane was removed from James River. Note damage in nose-wheel door area, dent in rear bomb door, hole near bottom turret, and damage to rudders. The skin was indented over lower half of fuselage in a strip just in front of the tail empennage.
